BATHYMETRY SURVEY, DEBRIS SAMPLING AND BULKHEAD SURVEY
KEY ALLEGRO CANAL AND PROPERTY OWNER ASSOCIATION, INC.
KEY ALLEGRO SUBDIVISION
KEY ALLEGRO, ROCKPORT, ARANSAS COUNTY, TEXAS

Prepared for:
Key Allegro Canal Property Owner Association
911 Navigation Circle
Rockport, TX 78382

Prepared by:
Belaire Environmental, Inc.
PO Box 741
Rockport, TX 78382

February 15, 2019

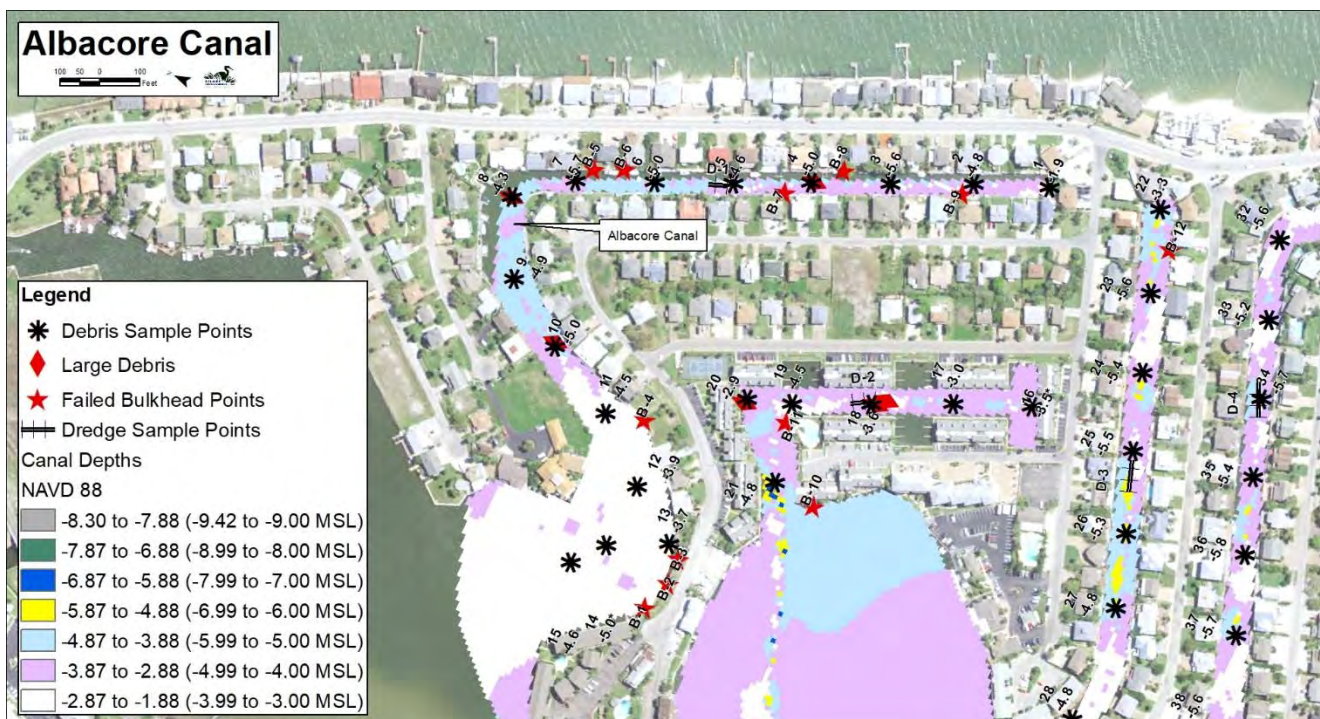
Nine visible bulkheads along Albacore Canal showed obvious signs of failure. Not all bulkheads were visible due to docks, boat slips, and other obstructions. The locations of the failed bulkheads are depicted on the map below. Additionally, Exhibit D shows photographic documentation of the failed bulkheads.

The Albacore Canal debris sampling included 15 grab sample locations and one 50-foot linear dredge. Debris found at these samples included metal, fishing line, shingles, plastic, wood, and organic matter. The organic matter classification consisted of leaves, sticks, and other various small organic plant debris. In the Albacore Canal, three pieces of large debris were located that could not be removed for identification. Typically, debris found within the canal was located within the top six inches of the sediment. Sample locations are shown in the map below and a breakdown of the debris is included within the table.

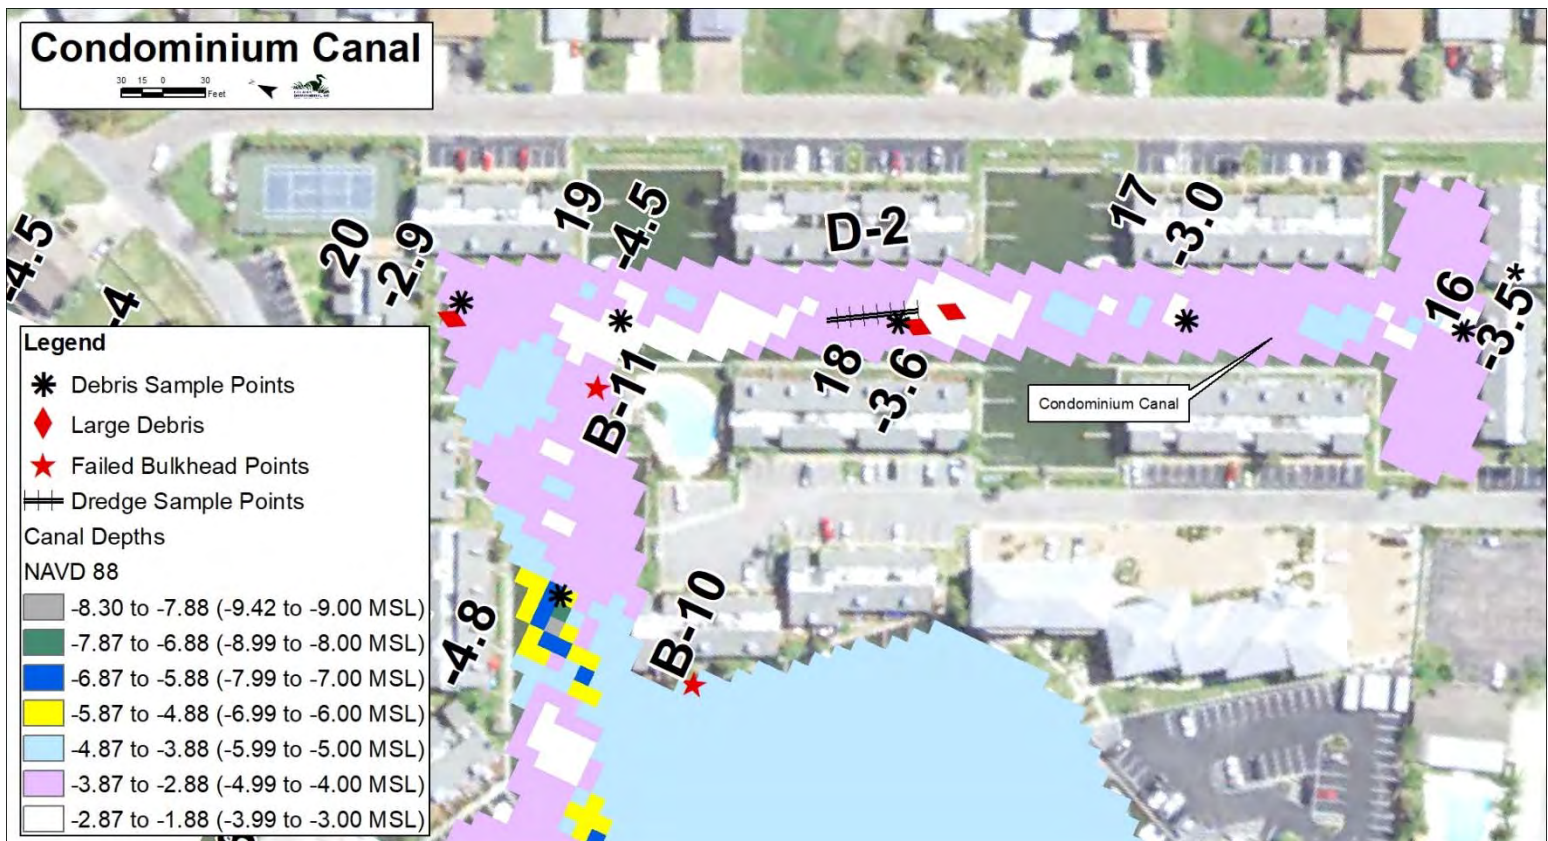
Two visible bulkheads along Condominium Canal showed obvious signs of failure. Not all bulkheads were visible due to docks, boat slips, and other obstructions. The locations of the failed bulkheads are depicted on the map below. Additionally, Exhibit D shows photographic documentation of the failed bulkheads.

The Condominium Canal debris sampling included six grab sample points and one 50-foot linear dredge. Debris found at these samples included large unidentified debris and organic matter. The organic matter classification consists of leaves, sticks, and other various small organic plant debris. In the Condominium Canal, three pieces of large debris were located that could not be removed for identification. Typically, debris found was located within the top six inches of sediment. Sample locations are shown in the map below and a breakdown of the debris is included within the table.

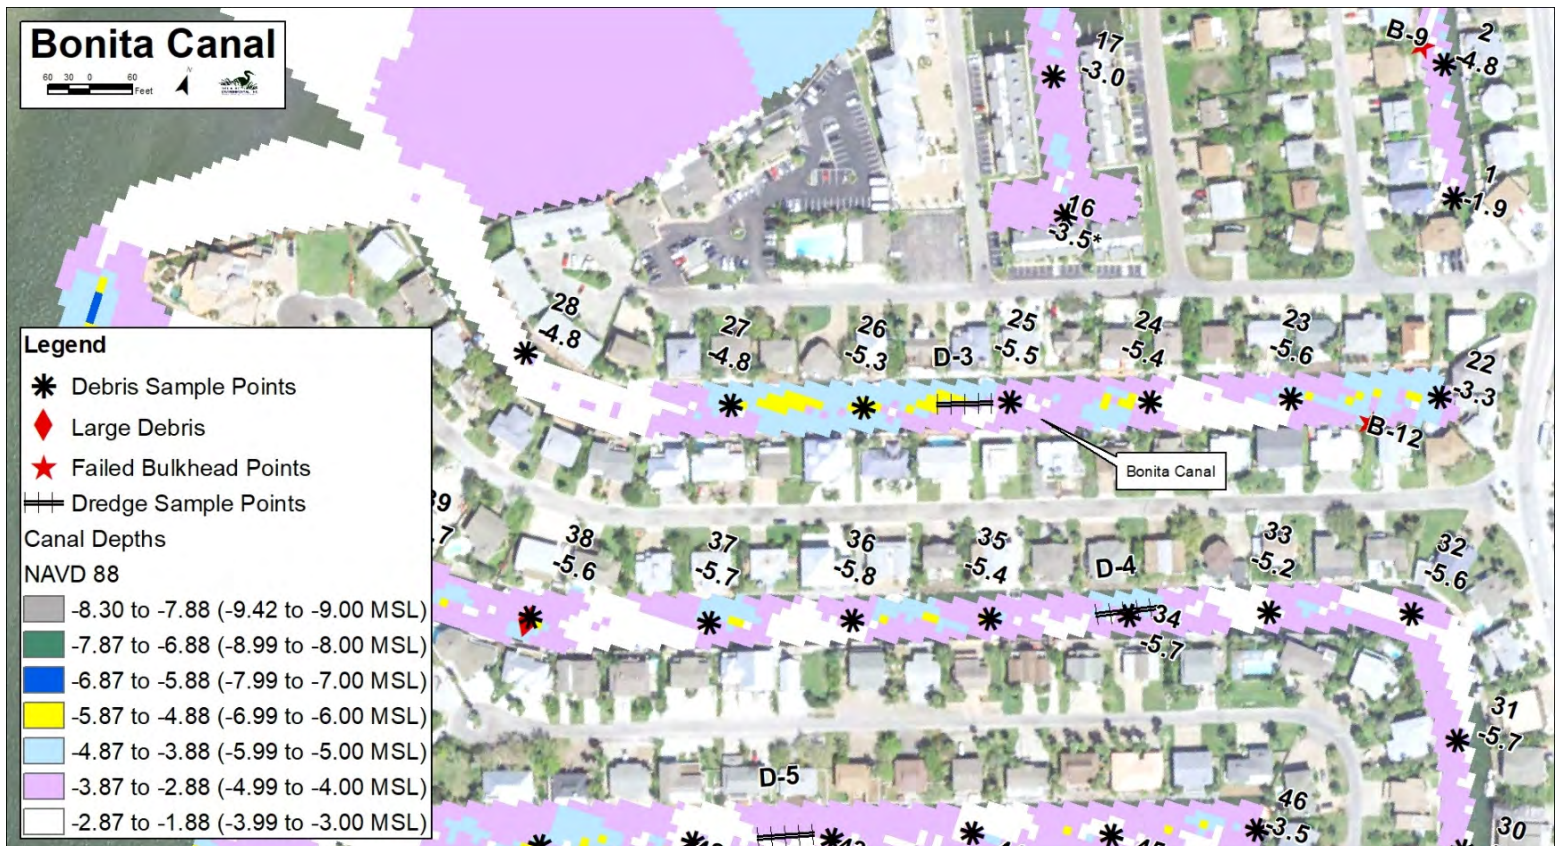
One visible bulkhead along Bonita Canal showed obvious signs of failure. Not all bulkheads were visible due to docks, boat slips, and other obstructions. The location of the failed bulkhead is depicted on the map below. Exhibit D shows photographic documentation of the failed bulkheads.

The Bonita Canal debris sampling included seven grab sample points and one 50-foot linear dredge. Debris found at these samples included shingles, concrete/rock, wood, and organic matter. The organic matter classification consists of leaves, sticks, and other various small organic plant debris. Typically, debris found was located within the top six inches of sediment. No large debris was found. Sample locations are shown in the map below and a breakdown of the debris is included within the table.

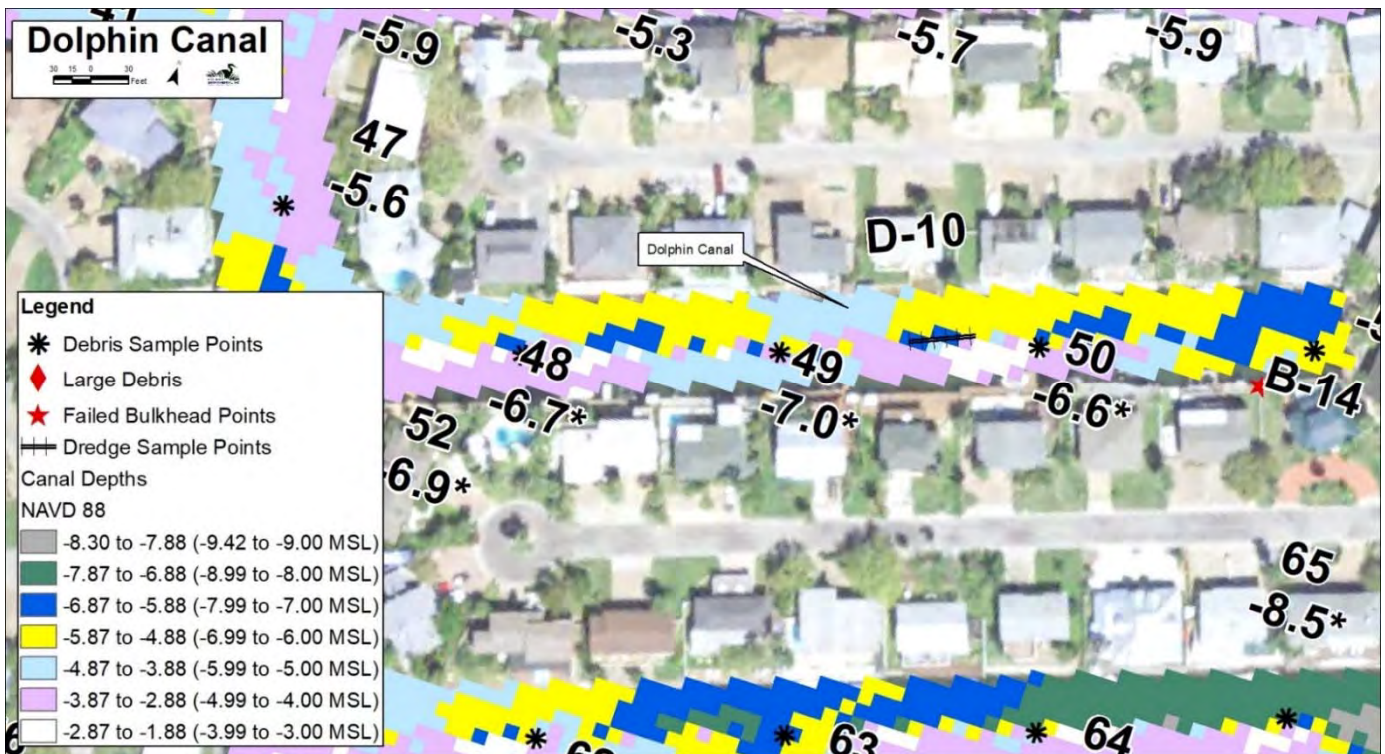
One visible bulkhead along Dolphin Canal showed obvious signs of failure. Not all bulkheads were visible due to docks, boat slips, and other obstructions. The locations of the failed bulkheads are depicted on the map below. Additionally, Exhibit D shows photographic documentation of the failed bulkheads.

The Dolphin Canal debris sampling included four grab sample points and one 50-foot linear dredge. Debris found at these samples included metal tape, insulation, partial shingles, and organic matter. The organic matter classification consists of leaves, sticks, and other various small organic plant debris. Typically, debris found was located within the top six inches of sediment. No large debris was found. Sample locations are shown in the map below and a breakdown of the debris is included within the table.

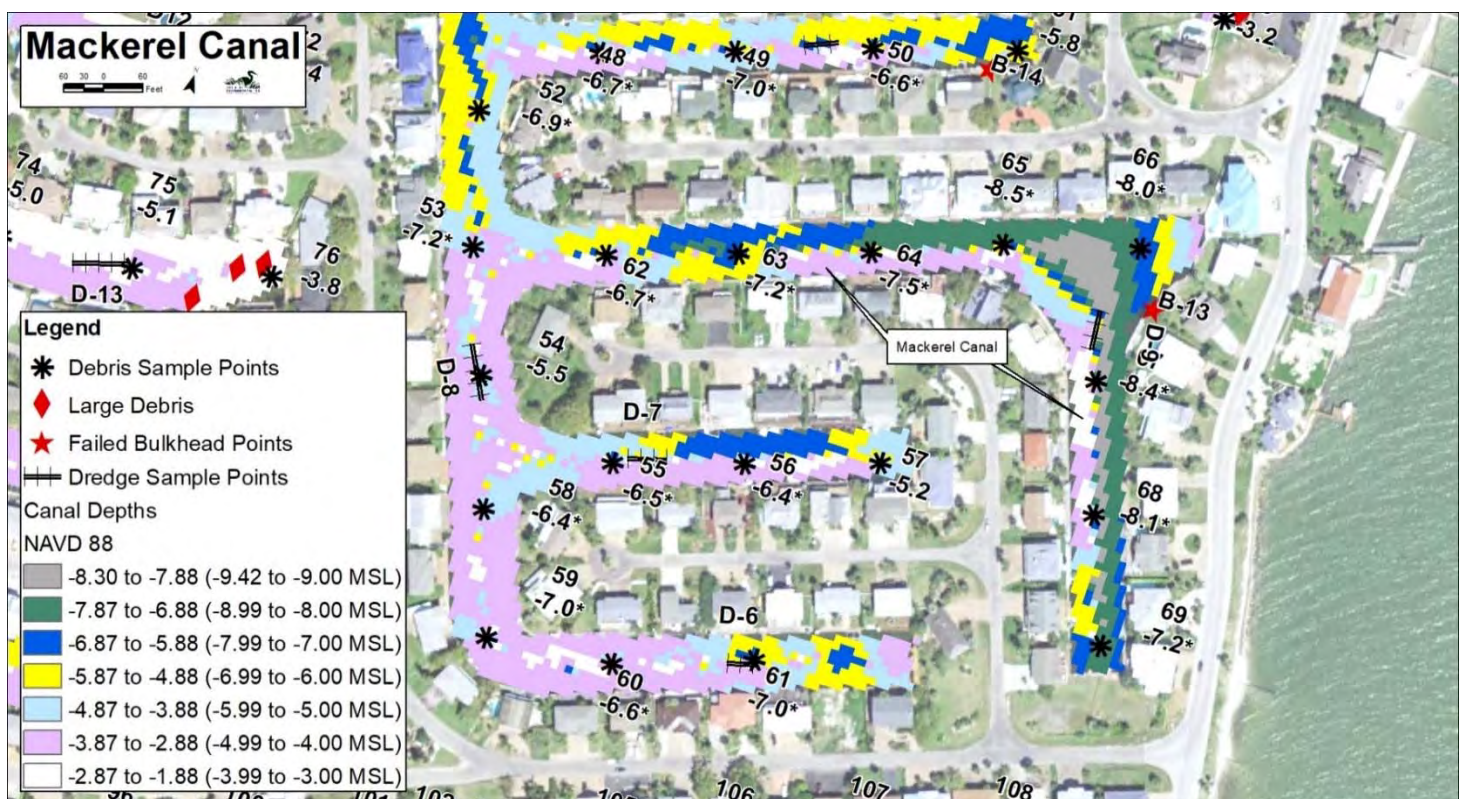
One visible bulkhead along Mackerel Canal showed obvious signs of failure. Not all bulkheads were visible due to docks, boat slips, and other obstructions. The location of the failed bulkhead is depicted on the map below. Additionally, Exhibit D shows photographic documentation of the failed bulkhead.

The Mackerel Canal debris sampling included eight grab sample points and one 50-foot linear dredge. Debris found at these samples included partial shingles, plastic, and organic matter. The organic matter classification consists of leaves, sticks, and other various small organic plant debris. Typically, debris found was located within the top six inches of sediment. No large debris was found. Sample locations are shown in the map below and a breakdown of the debris is included within the table.

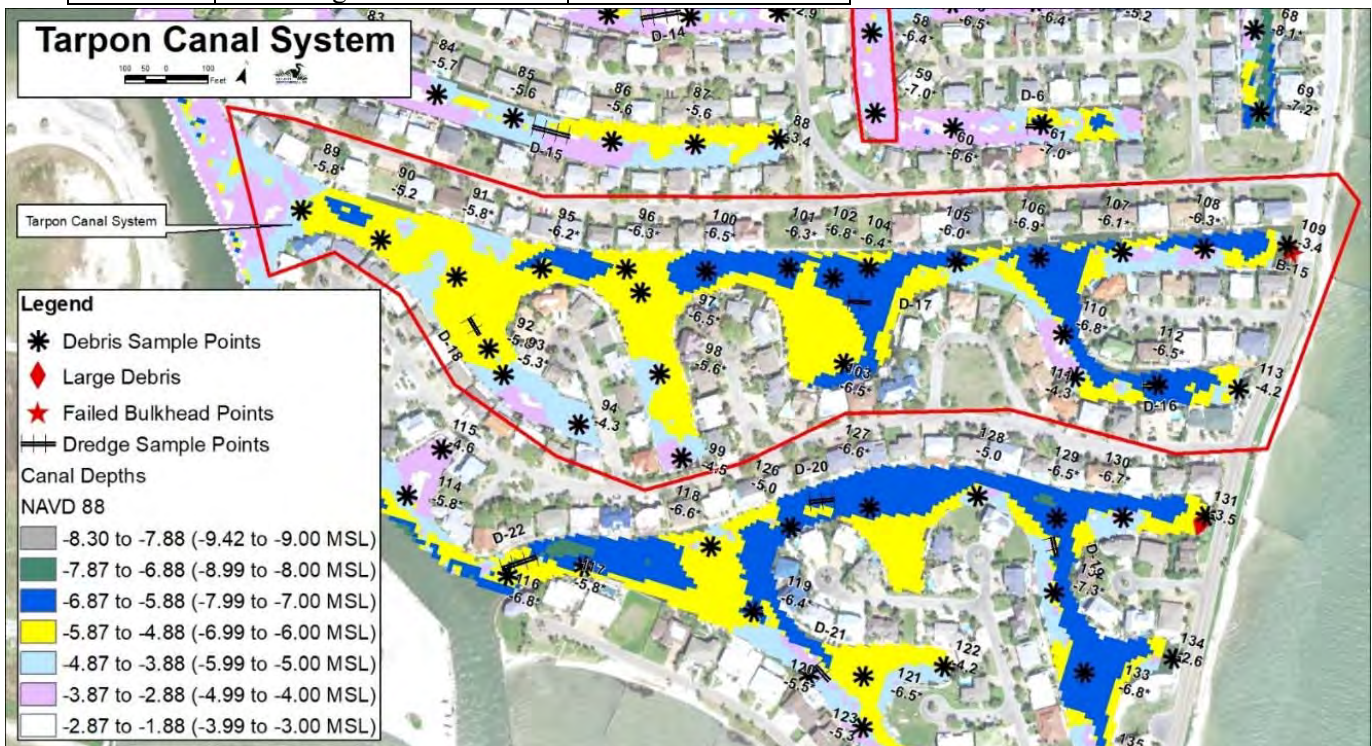
One visible bulkhead along Tarpon Canal System showed obvious signs of failure. Not all bulkheads were visible due to docks, boat slips, and other obstructions. The location of the failed bulkhead is depicted on the map below. Additionally, Exhibit D shows photographic documentation of the failed bulkheads.

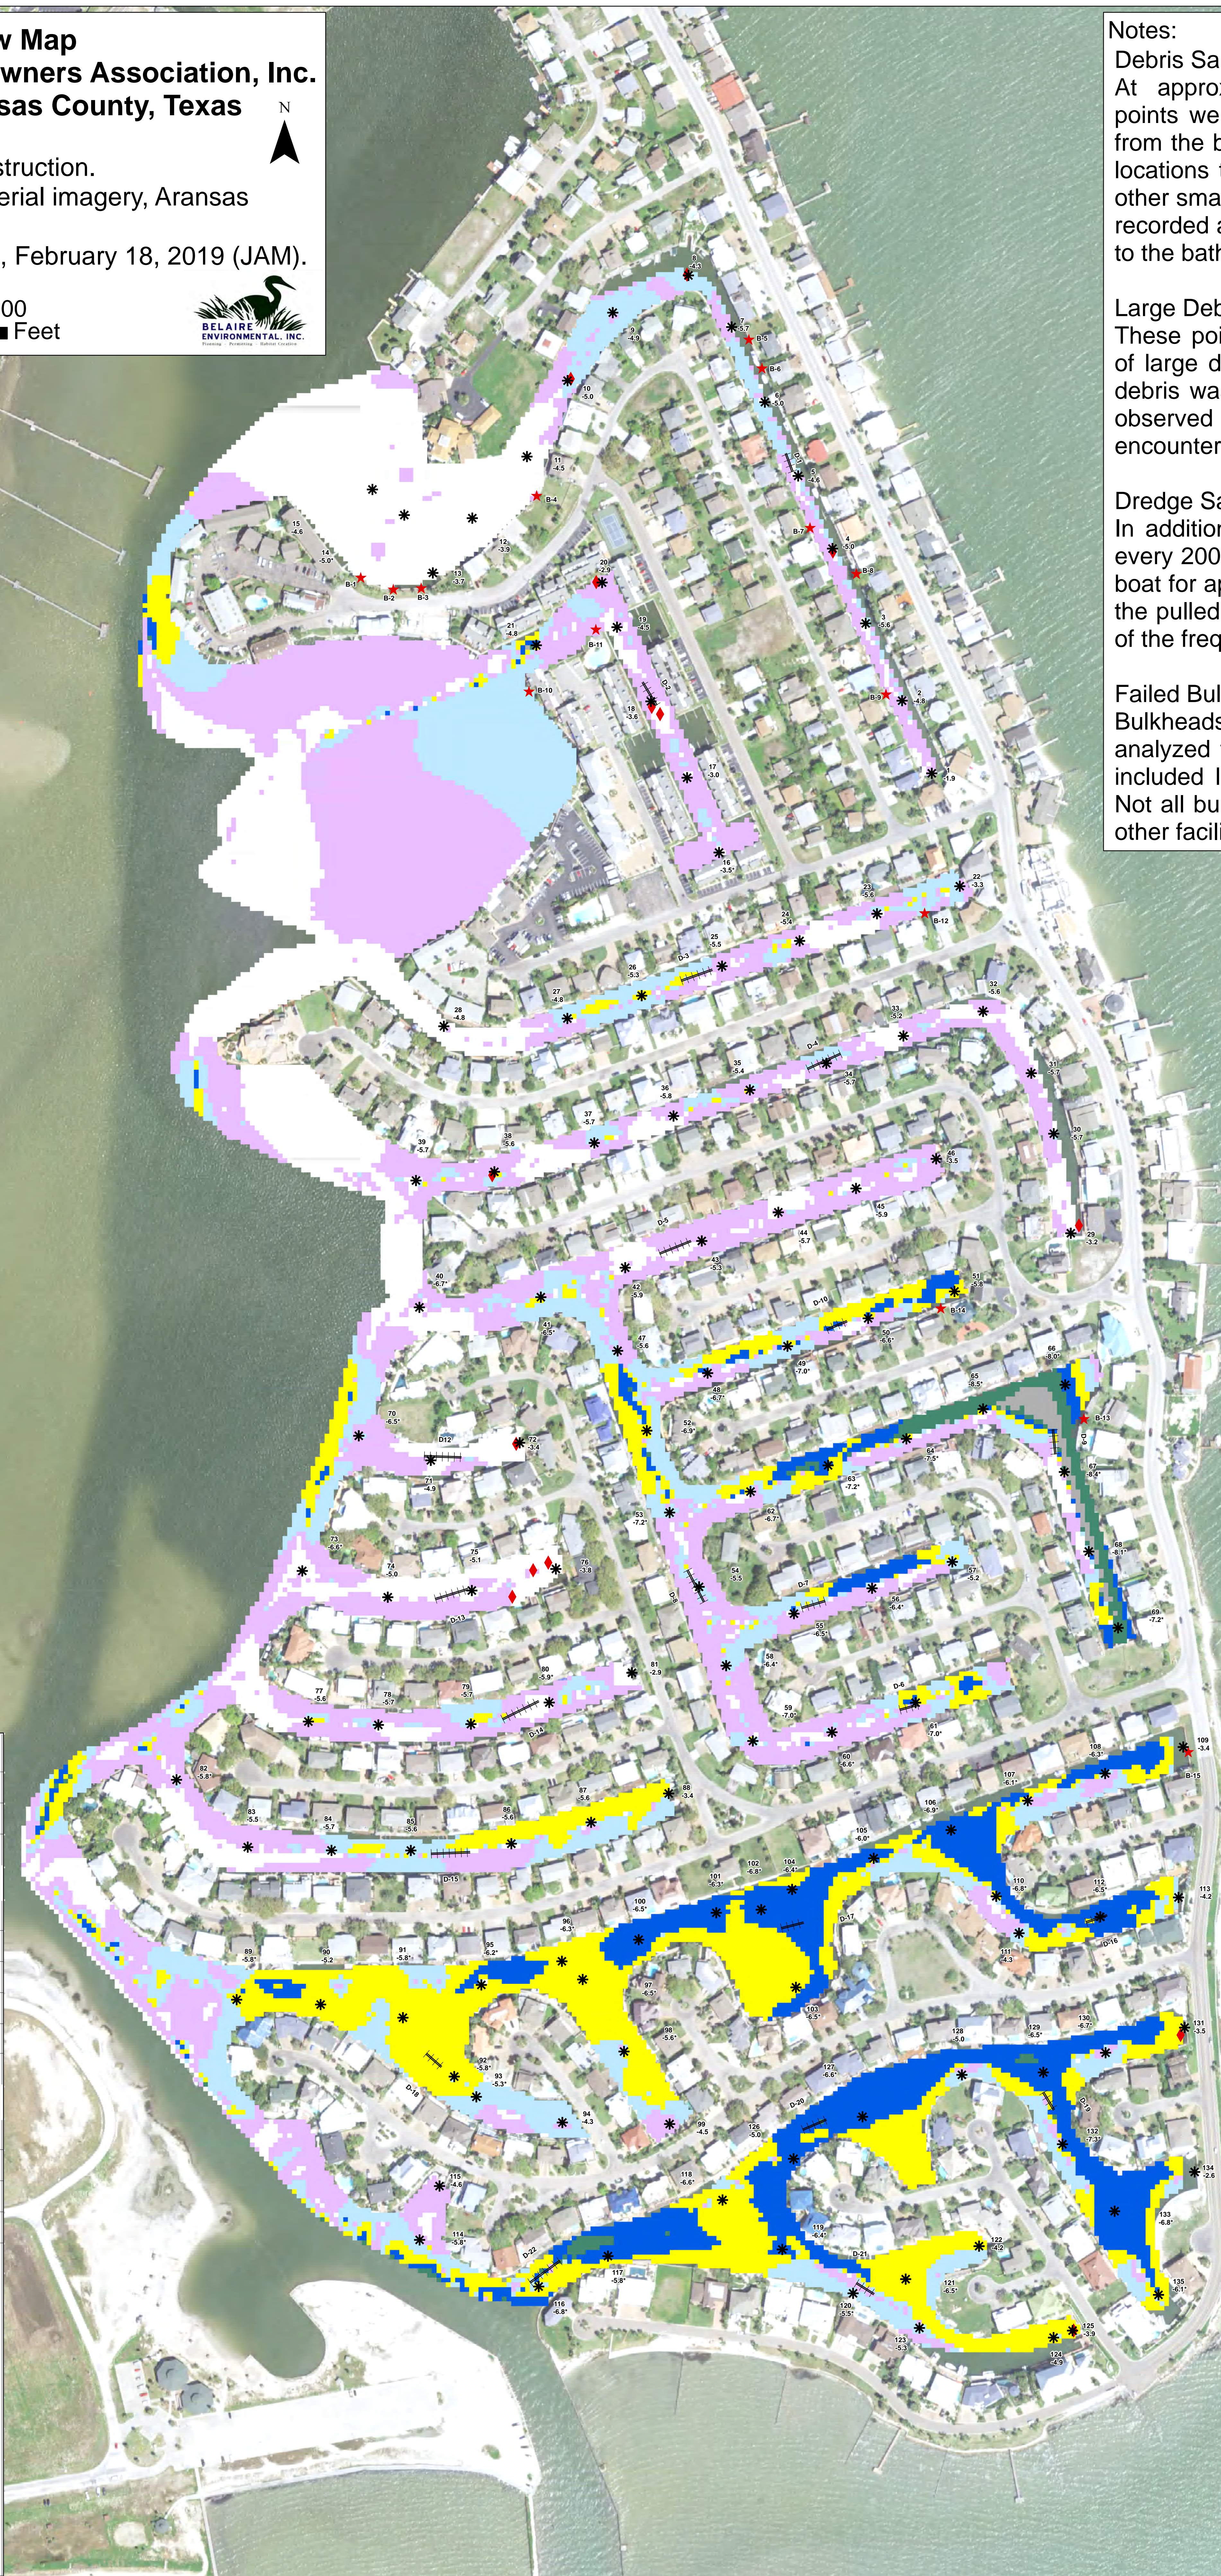
Failed Bulkheads:

Bulkheads that were visible from the boat were analyzed for obvious physical signs of failure. Failures included large cracks, subsidence, or visual washout. Not all bulkheads were visible due to boats ramps and other facilities.
