MOTT
MACDONALD

Key Allegro Preliminary Bulkhead Repair Engineering Analysis

Technical Memorandum

October 17, 2017

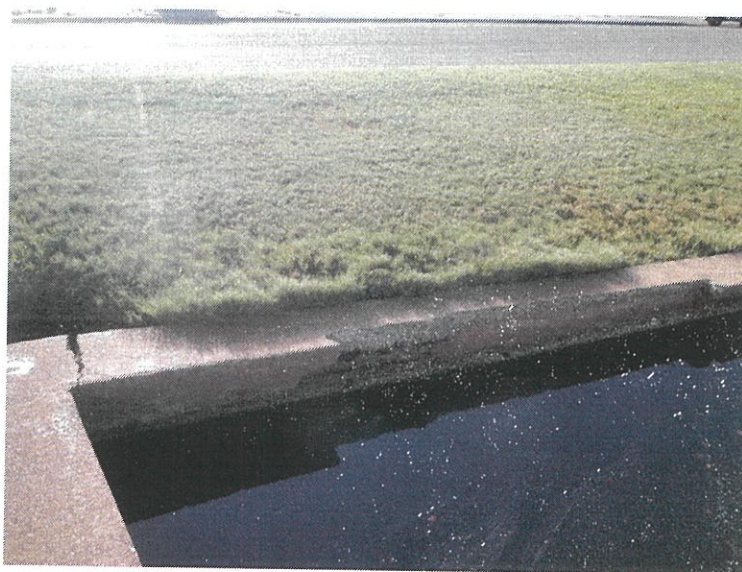
As the concrete cap reaches the end of its design life; loss of strength in the concrete and/or reinforcement corrosion causes the cap to crack. Minor cracks should be monitored frequently while major cracks may require repair or replacement of the caps. The cap in Figure 4 is severely cracked and the enclosed reinforcing (steel rebar) has been exposed and begun to corrode. Due to the extent of damage to this cap, it should be replaced. The bulkhead has also begun to subside at this location which will require additional repairs.

Figure 4: Deteriorating bulkhead cap

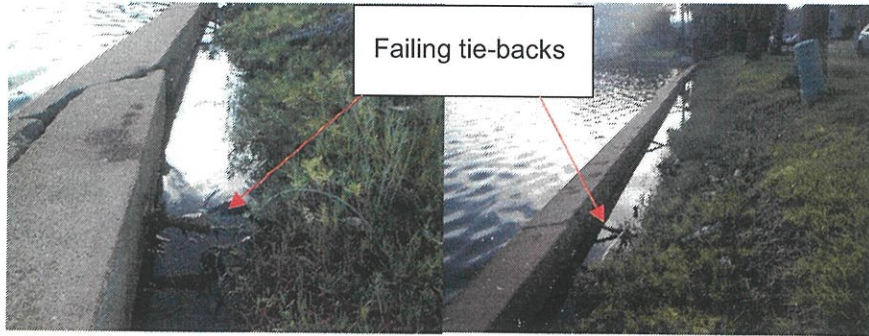
Due to the age of the bulkheads, tie-back failure should be expected. A tie-back is a horizontal rod typically secured to the bulkhead on one end and concrete anchor (deadman) driven into the ground on the other end. The tie-backs in Figure 5 have been severely corroded due to their age and exposure to a corrosive environment. Tie backs have also been cut in some locations by property owners to allow installation of other structures such as swimming pools. Once tie-back failure is severe or tie-backs are cut the bulkhead will begin to lean forward as shown. Tie backs shall be inspected prior to undertaking a repair of the bulkhead as failure of these will result in failure of the entire structure. Due to the advanced age of the bulkheads and tie-backs, Mott MacDonald recommends all tie backs be replaced during bulkhead repair.

Figure 5: Exposed tie-backs showing failure

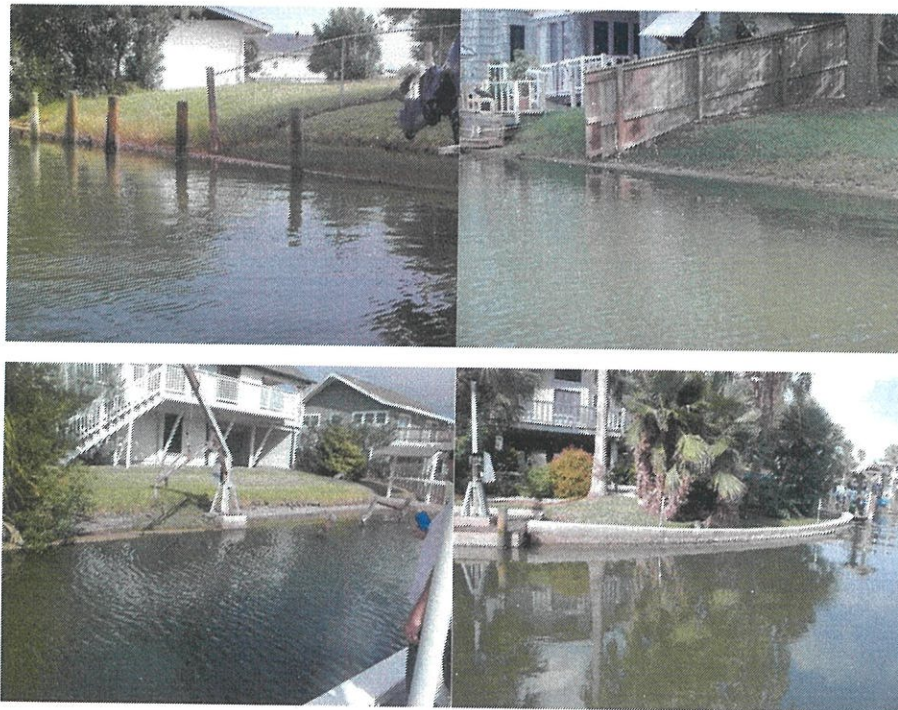
Several bulkheads throughout Key Allegro have subsided below +1' MSL, and in some locations the top of the cap has become partially submerged. This subsidence exposes the bulkhead to overtopping which can erode that land behind the structure, corrode the wall anchor tie backs, and lead to total failure of the structure and loss of land behind the bulkhead.

Figure 6: Examples of subsided bulkheads with limited freeboard

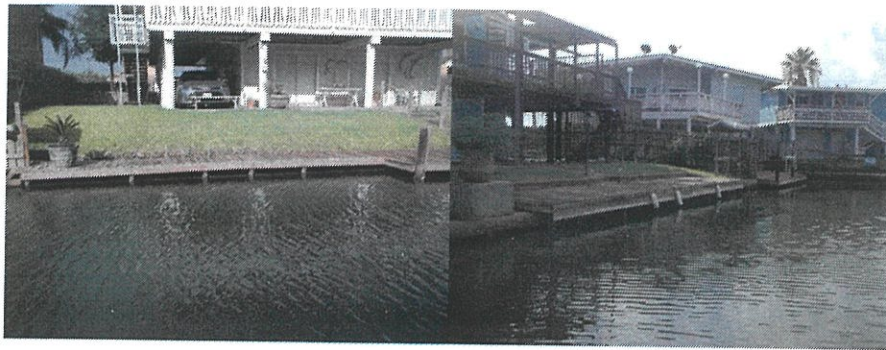
In several locations, homeowners have built structures over existing bulkheads. Small structures such as decks and docks should have a limited impact on the bulkhead, but may need to be temporarily removed in order to access the bulkhead for repair. Such a structure is shown in Figure 7.

Figure 7: Decking constructed over existing concrete bulkhead

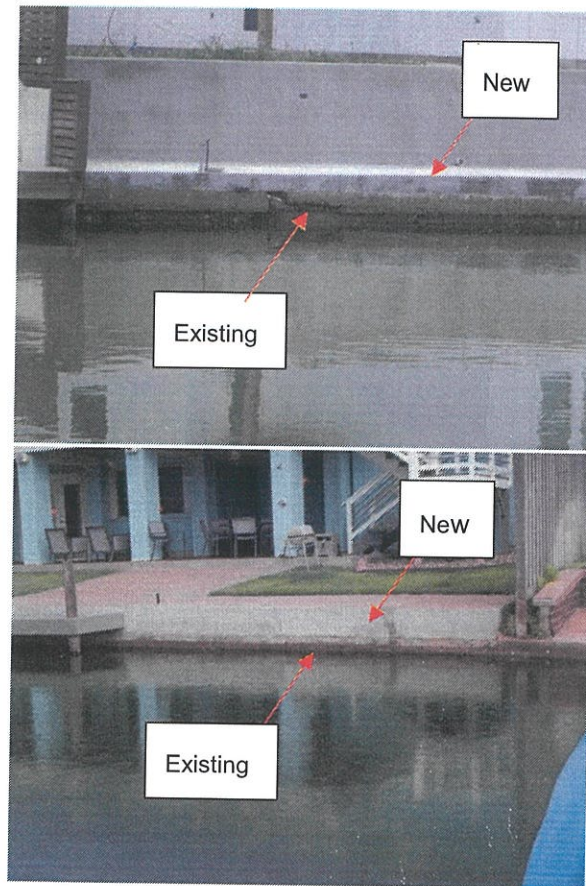
In some locations, concrete slabs and other structures of significance have been built on top of the bulkheads by homeowners to address the subsidence of the existing wall and provide additional freeboard to the structure. This should be avoided as, although they temporarily increase the cap elevation above the KACOPA minimum requirement, the structures create additional surcharge loads which the bulkhead was not designed to support, or may not presently have the structural capacity to support. Combined with an aging bulkhead, these structures are more likely to accelerate the failure of the bulkhead over time if the necessary repairs are not performed and designed to support the additional load prior to building of the structures. Owners should ensure that their bulkhead is in good condition and of adequate structural capacity to withstand the additional load prior to building directly over or adjacent to their bulkheads.

Figure 8: Concrete platforms constructed on top of existing bulkhead

Such structures also complicate the inevitable repair of the bulkheads as they may need to be removed in order to access the failing tie-back anchors, concrete caps, and sheet pile. In addition, if such structures are to remain or are to be constructed, the bulkhead repair shall be of sufficient capacity to withstand the additional load from the structures. Alternative options for tie-back installation may be necessary in locations where structures have been constructed where normal tie-backs and anchors would need to be installed. Anchor tie-back options such as helical anchors, grouted anchors, and tie-backs may be preferred in these locations to avoid impacting existing structures.
