BATHYMETRY SURVEY, DEBRIS SAMPLING AND BULKHEAD SURVEY
KEY ALLEGRO CANAL AND PROPERTY OWNER ASSOCIATION, INC.
KEY ALLEGRO SUBDIVISION
KEY ALLEGRO, ROCKPORT, ARANSAS COUNTY, TEXAS

Prepared for:
Key Allegro Canal Property Owner Association
911 Navigation Circle
Rockport, TX 78382

Prepared by:
Belaire Environmental, Inc.
PO Box 741
Rockport, TX 78382

February 15, 2019

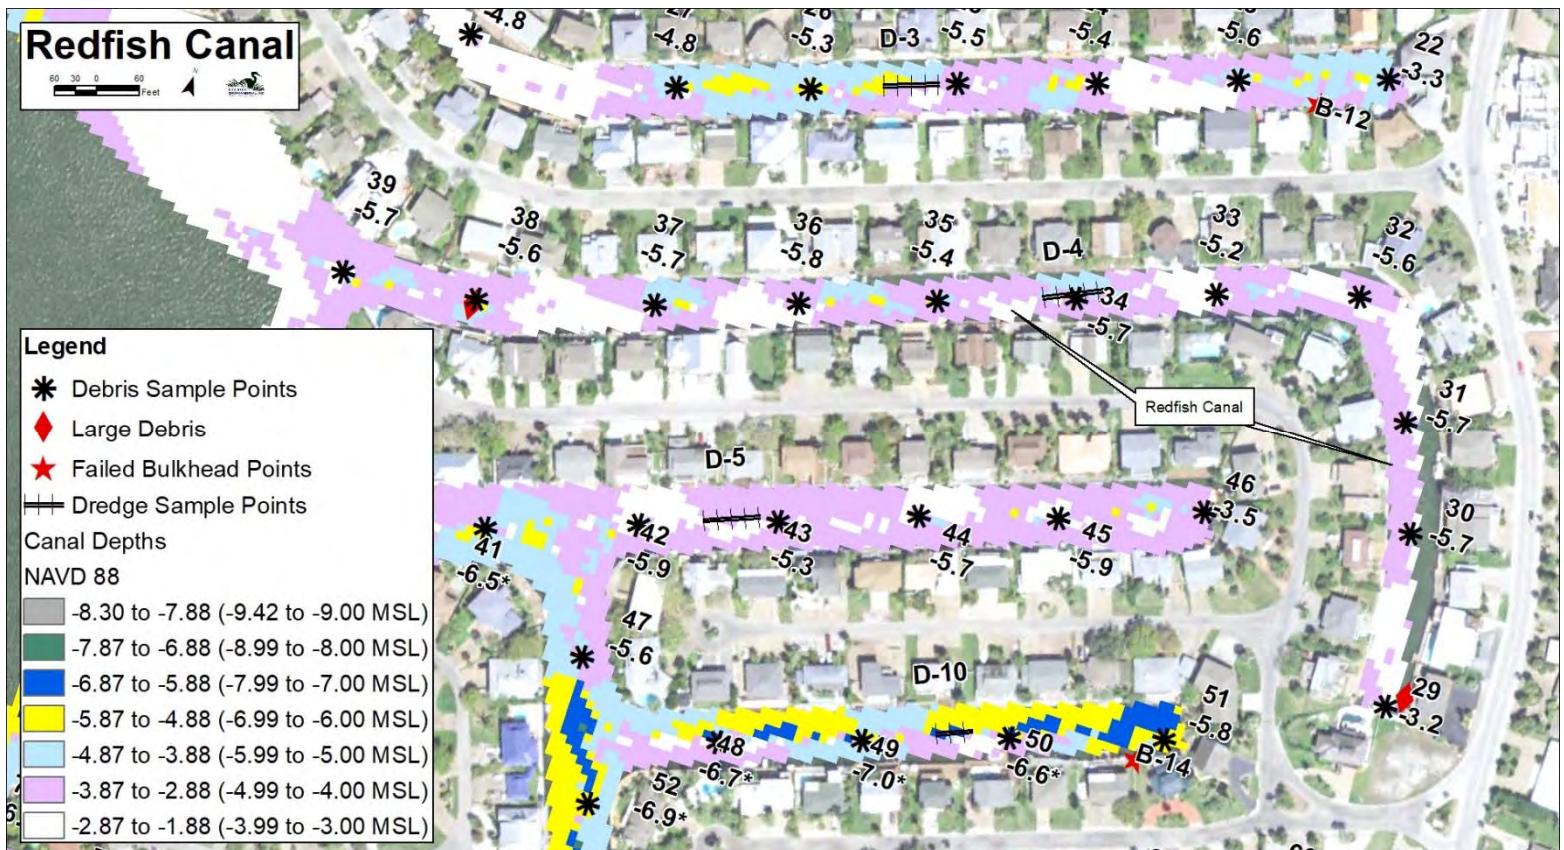
Visible bulkheads along Redfish Canal showed no obvious signs of failure. Not all bulkheads were visible due to docks, boat slips, and other obstructions.

The Redfish Canal debris sampling included eleven grab sample points and one 50-foot linear dredge. Debris found at these samples included shingles, shingle tabs, plastic, and organic debris. The organic matter classification consists of leaves, sticks, and other various small organic plant debris. In the Redfish Canal, two pieces of large debris were located that could not be removed for identification. Typically, debris found was located within the top six inches of sediment. Sample locations are shown in the map below and a breakdown of the debris is included within the table.

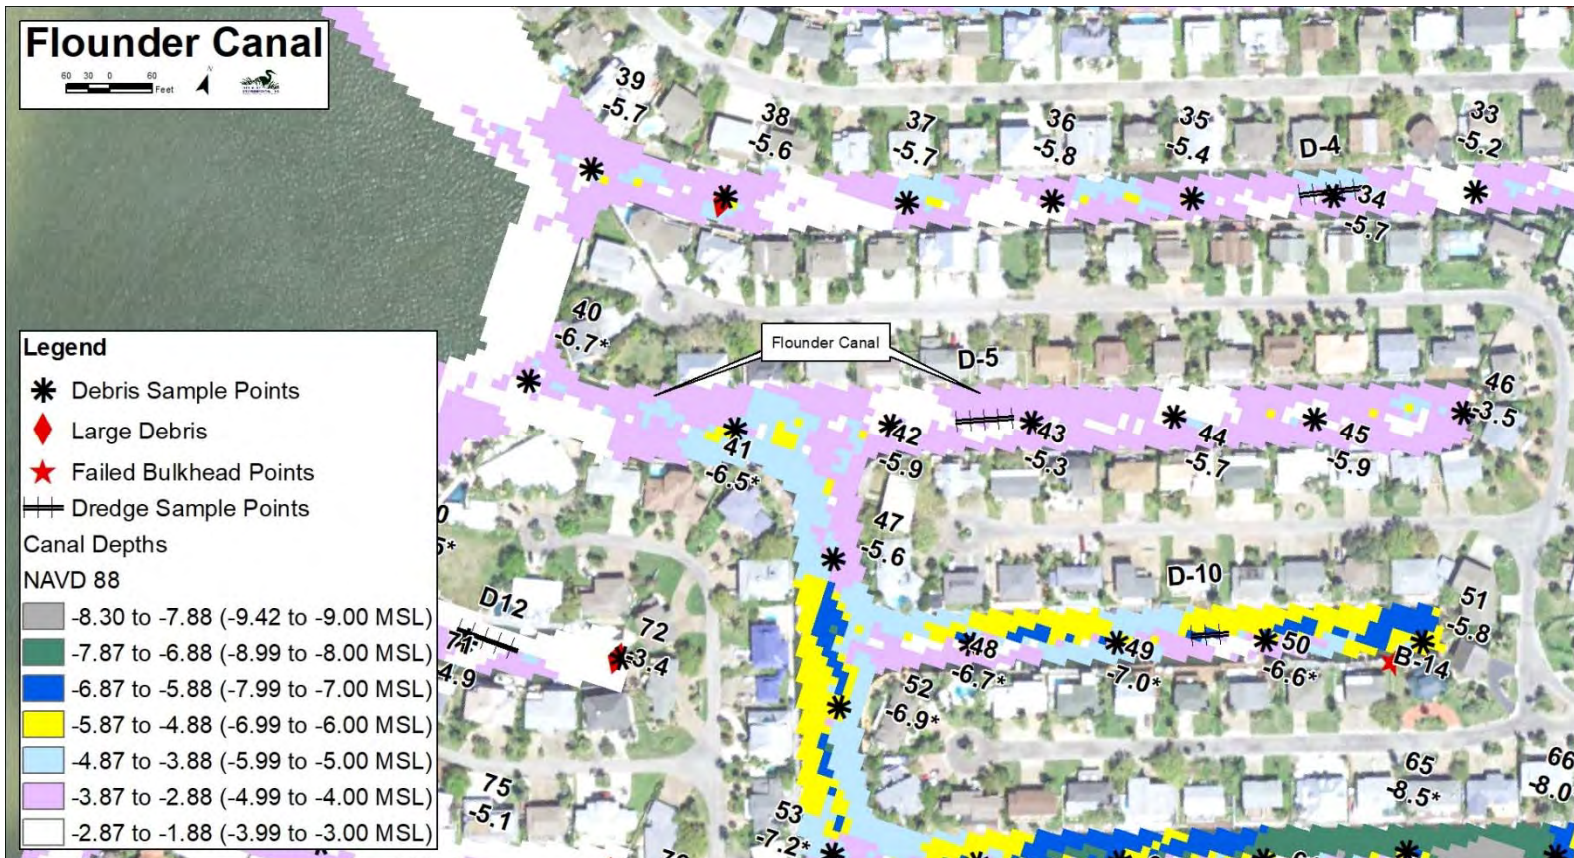
Visible bulkheads along Flounder Canal showed no obvious signs of failure. Not all bulkheads were visible due to docks, boat slips, and other obstructions.

The Flounder Canal debris sampling included seven grab sample points and one 50-foot linear dredge. Debris found at these samples include fabric, partial shingles, plastic, and organic matter. The organic matter classification consists of leaves, sticks, and other various small organic plant debris. Typically, debris found was located within the top six inches of sediment. No large debris was found. Sample locations are shown in the map below and a breakdown of the debris is included within the table.

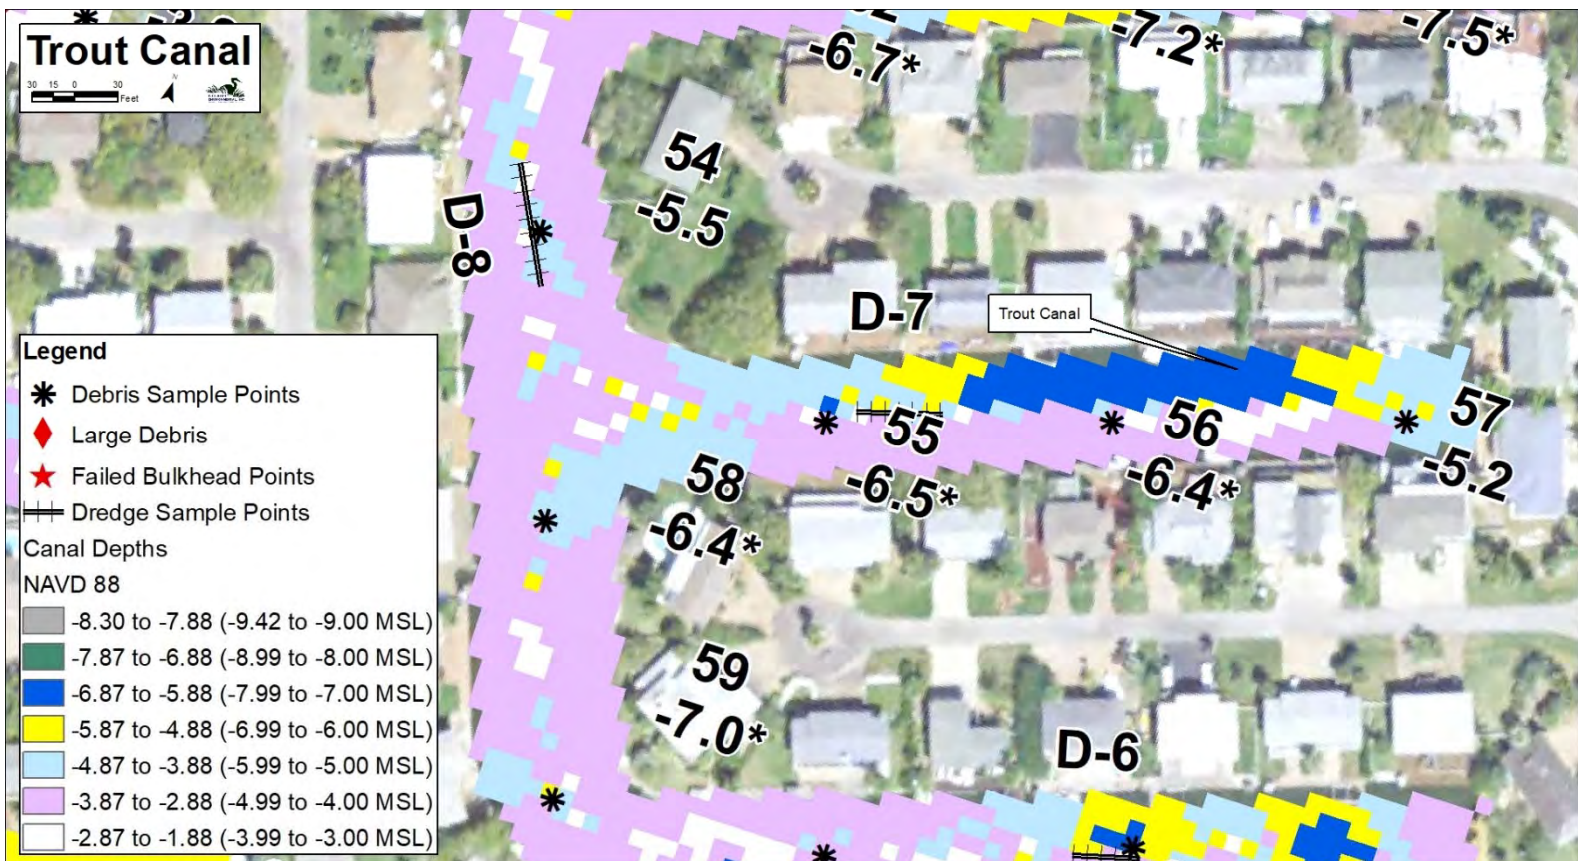
Visible bulkheads along Trout Canal showed no obvious signs of failure. Not all bulkheads were visible due to docks, boat slips, and other obstructions.

The Trout Canal debris sampling included three grab sample points and one 50-foot linear dredge. Debris found at these samples included partial shingles, plastic, insulation, and organic matter. The organic matter classification consists of leaves, sticks, and other various small organic plant debris. Typically, debris found was located within the top six inches of sediment. No large debris was found. Sample locations are shown in the map below and a breakdown of the debris is included within the table.

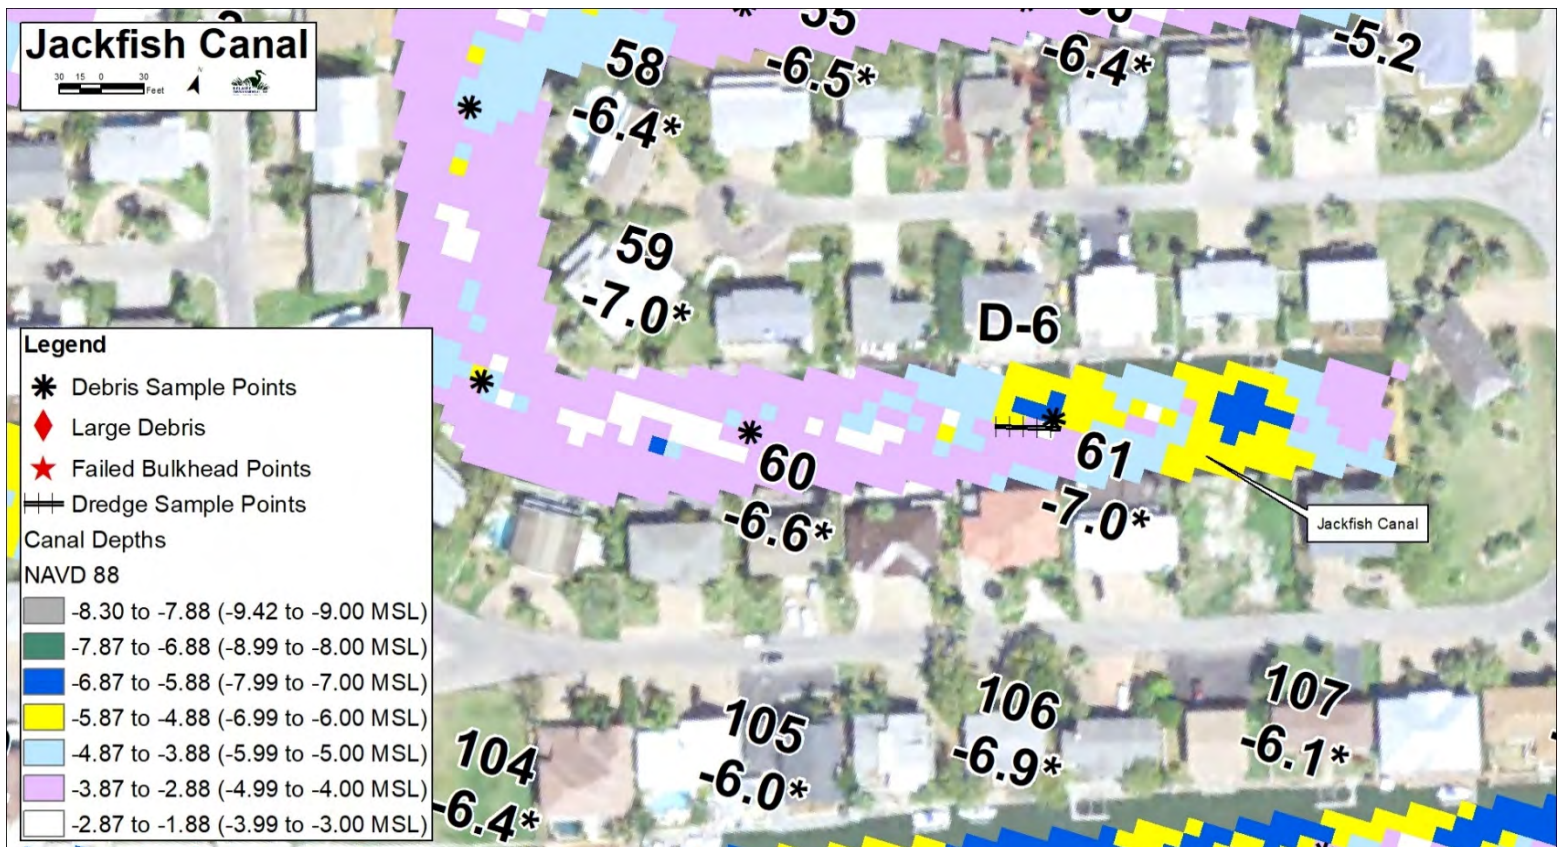
Visible bulkheads along Jackfish Canal showed no obvious signs of failure. Not all bulkheads were visible due to docks, boat slips, and other obstructions.

The Jackfish Canal debris sampling included two grab sample points and one 50-foot linear dredge. Debris found at these samples included shingles, plastic, wood, and organic matter. The organic matter classification consists of leaves, sticks, and other various small organic plant debris. Typically, debris found was located within the top six inches of sediment. No large debris was found. Sample locations are shown in the map below and a breakdown of the debris is included within the table.

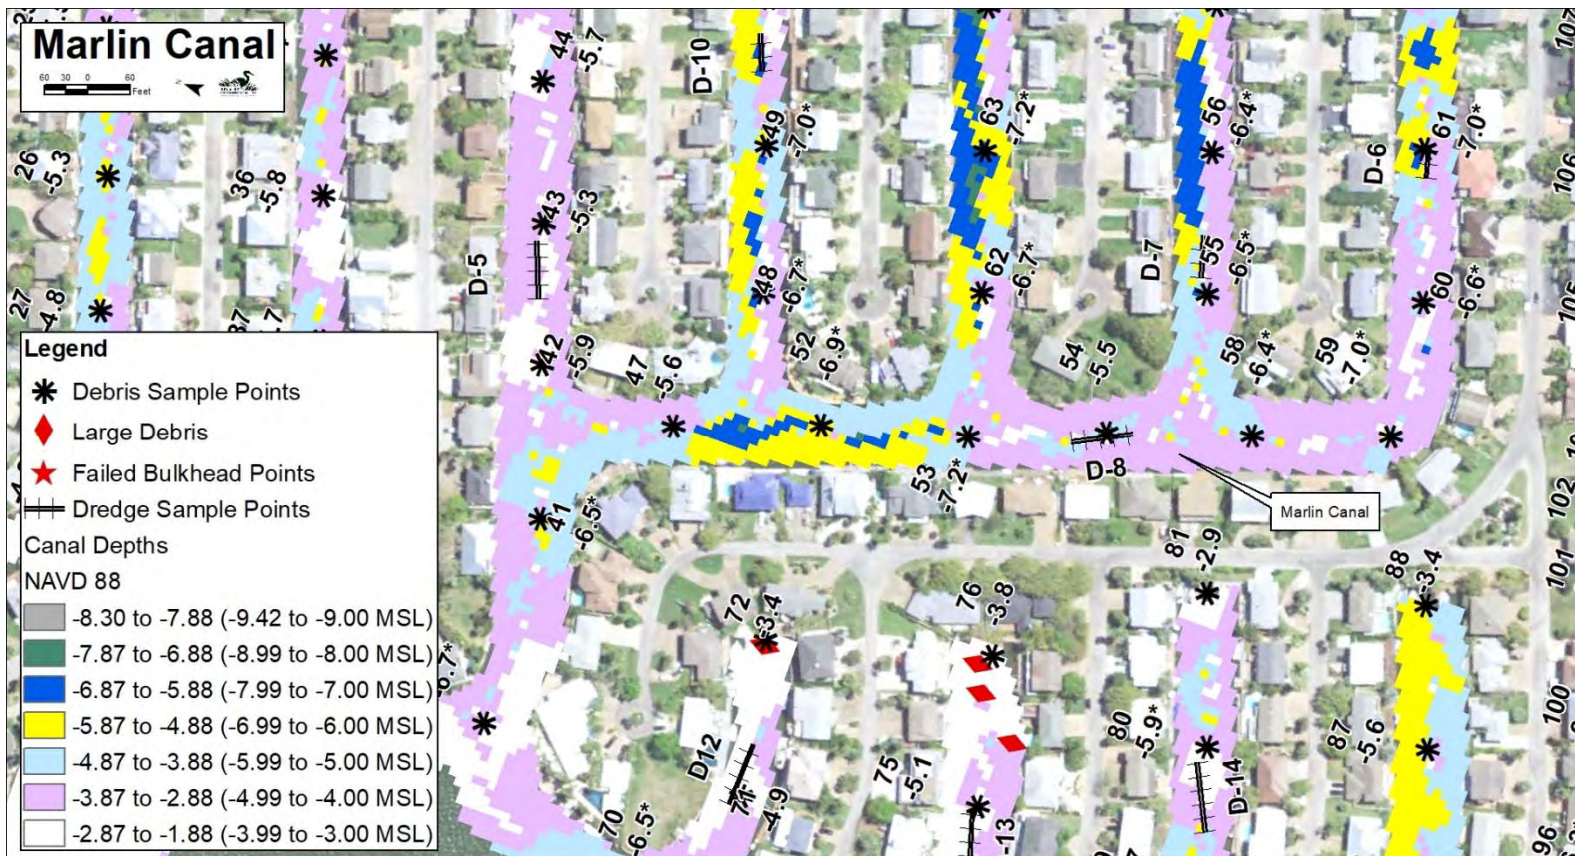
Visible bulkheads along Marlin Canal showed no obvious signs of failure. Not all bulkheads were visible due to docks, boat slips, and other obstructions.

The Marlin Canal debris sampling included six grab sample points and one 50-foot linear dredge. Debris found at these samples included shingles, an electrical box for a light fixture with wiring still attached, plastic, and organic matter. The organic matter classification consists of leaves, sticks, and other various small organic plant debris. Typically, debris found was located within the top six inches of sediment. No large debris was found. Sample locations are shown in the map below and a breakdown of the debris is included within the table.

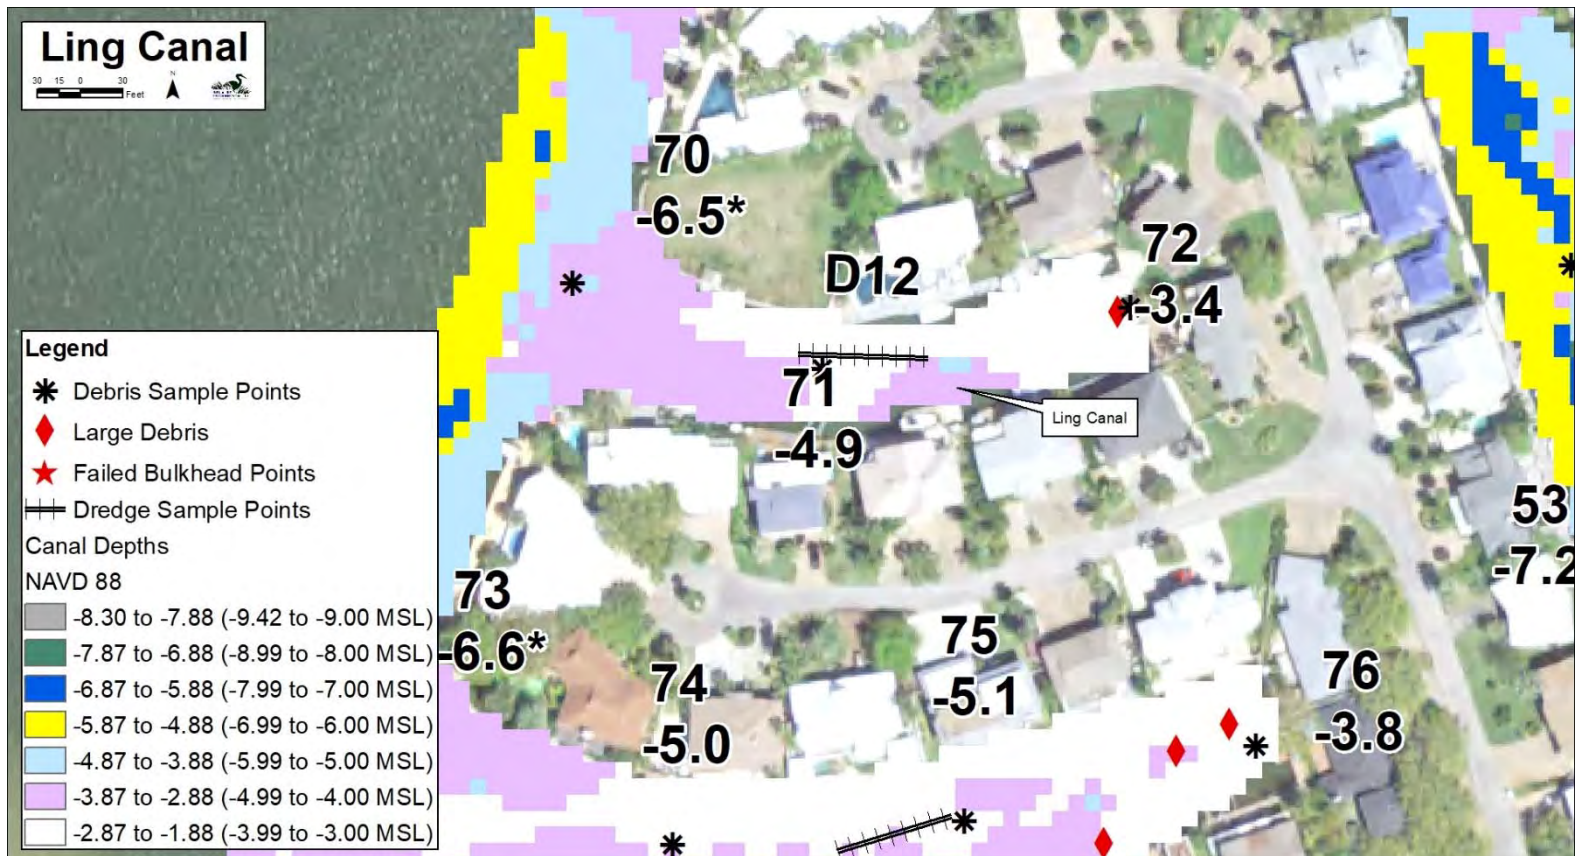
Visible bulkheads along Ling Canal showed no obvious signs of failure. Not all bulkheads were visible due to docks, boat slips, and other obstructions.

The Ling Canal debris sampling included three grab sample points and one 50-foot linear dredge. Debris found at these samples included fishing line, partial shingles, and organic matter. The organic matter classification consists of leaves, sticks, and other various small organic plant debris. In the Ling Canal, one piece of large debris was located that could not be removed for identification. Typically, debris found was located within the top six inches of sediment. Sample locations are shown in the map below and a breakdown of the debris is included within the table.

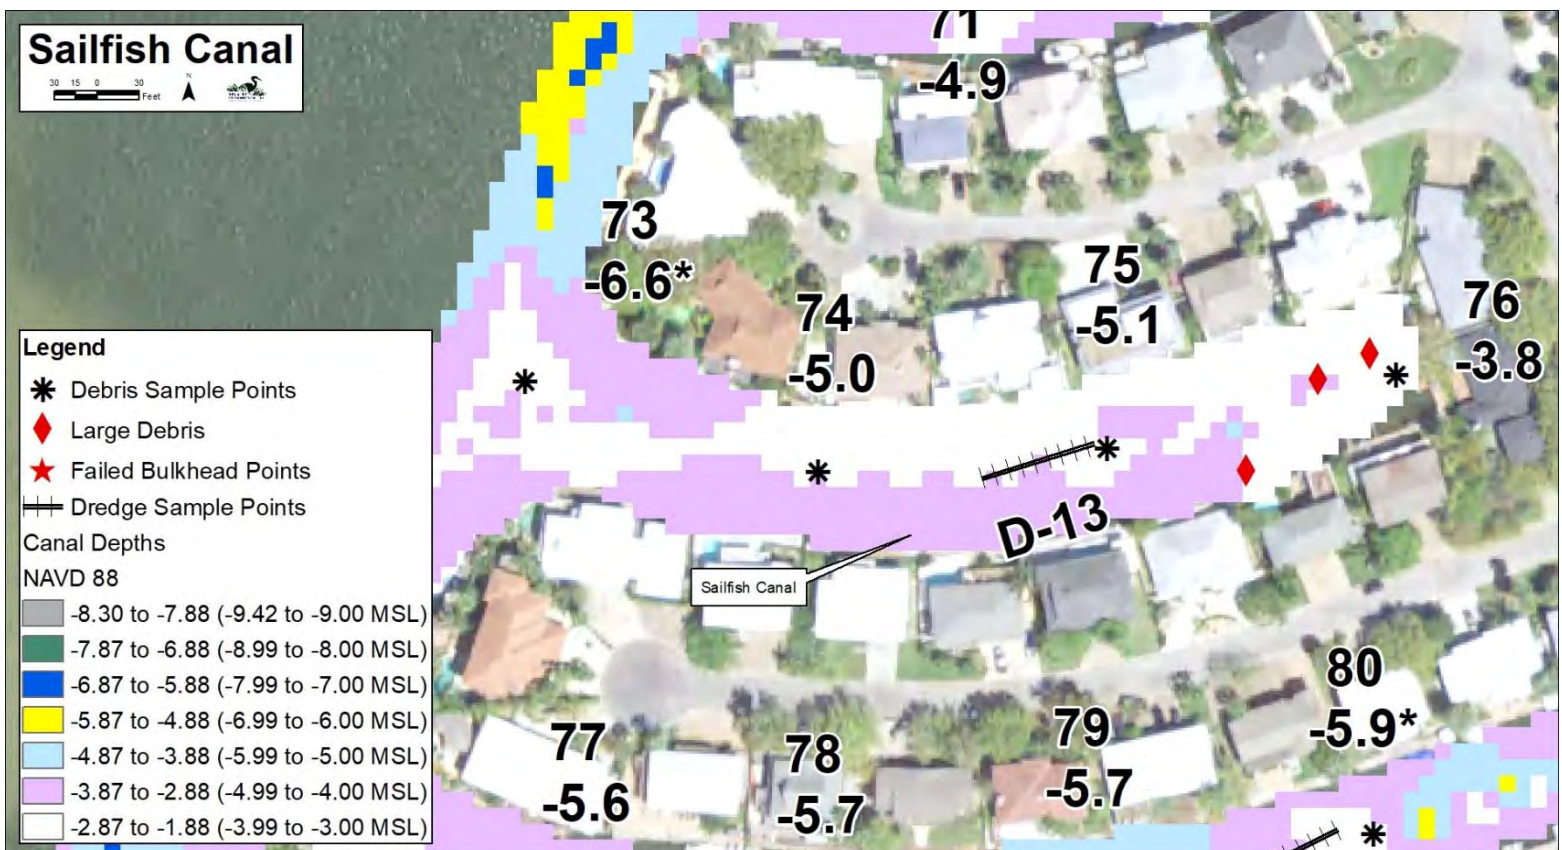
Visible bulkheads along Sailfish Canal showed no obvious signs of failure. Not all bulkheads were visible due to docks, boat slips, and other obstructions.

The Sailfish Canal debris sampling included four grab sample points and one 50-foot linear dredge. Debris found at these samples included plastic, a whole circular saw blade, shingles, a section of a bungee strap, and organic matter. The organic matter classification consists of leaves, sticks, and other various small organic plant debris. In the Sailfish Canal, two pieces of large debris were located that could not be removed for identification. Typically, debris found was located within the top six inches of sediment. Sample locations are shown in the map below and a breakdown of the debris is included within the table.

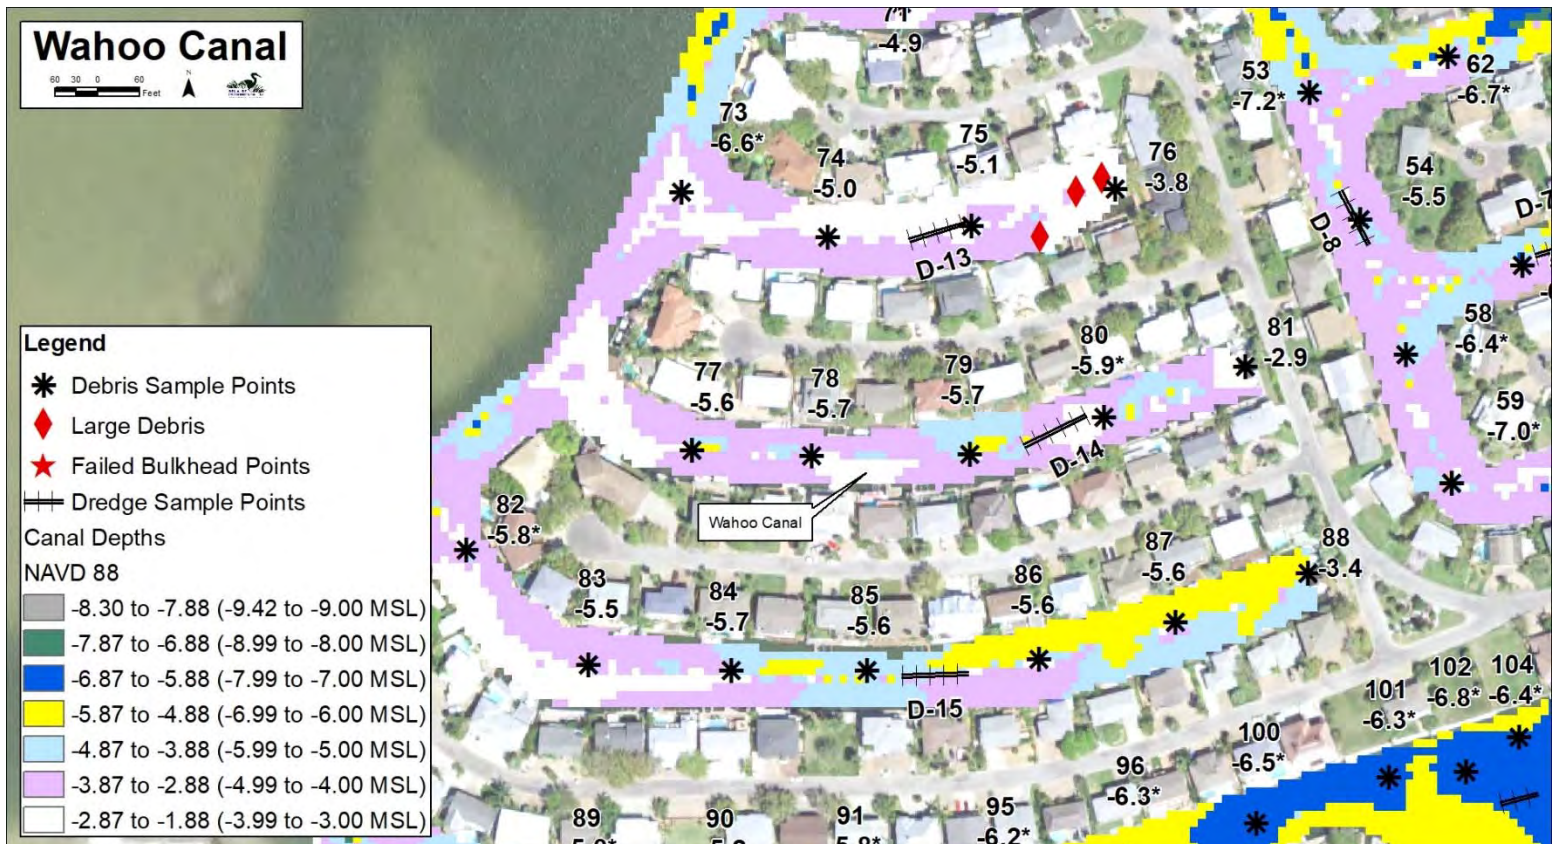
Visible bulkheads along Wahoo Canal showed no obvious signs of failure. Not all bulkheads were visible due to docks, boat slips, and other obstructions.

The Wahoo Canal debris sampling included five grab sample points and one 50-foot linear dredge. Debris found at these samples included a nail, partial shingles, plastic, and organic matter. The organic matter classification consists of leaves, sticks, and other various small organic plant debris. No large debris was found. Typically, debris found was located within the top six inches of sediment. Sample locations are shown in the map below and a breakdown of the debris is included within the table.

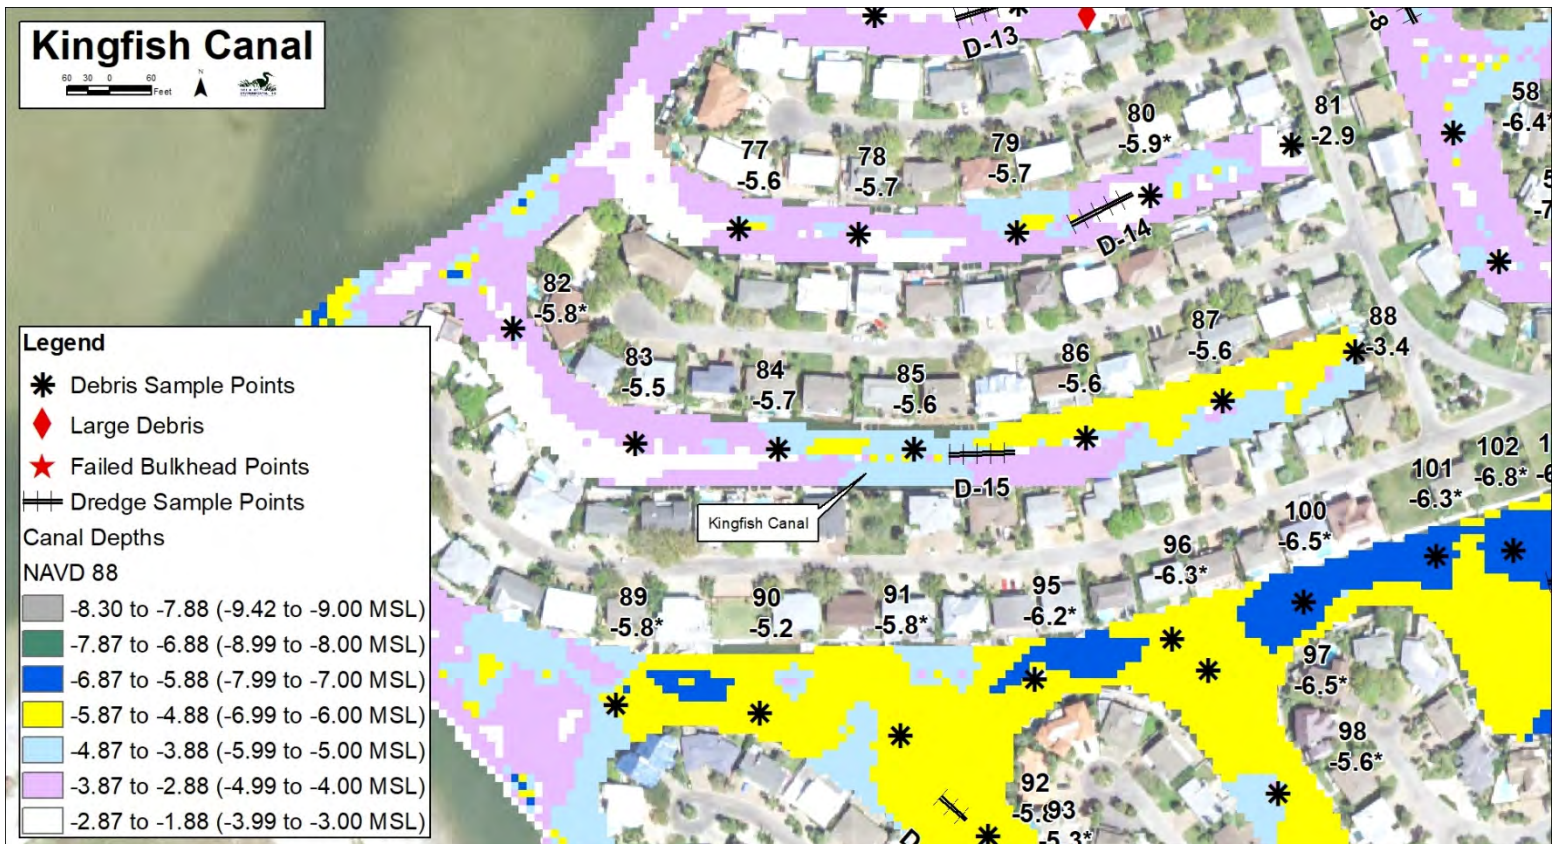
Visible bulkheads along Kingfish Canal showed no obvious signs of failure. Not all bulkheads were visible due to docks, boat slips, and other obstructions.

The Kingfish Canal debris sampling included seven grab sample points and one 50-foot linear dredge. Debris found at these samples included shingles and organic matter. The organic matter classification consists of leaves, sticks, and other various small organic plant debris. Typically, debris found was located within the top six inches of sediment. No large debris was found. Sample locations are shown in the map below and a breakdown of the debris is included within the table.

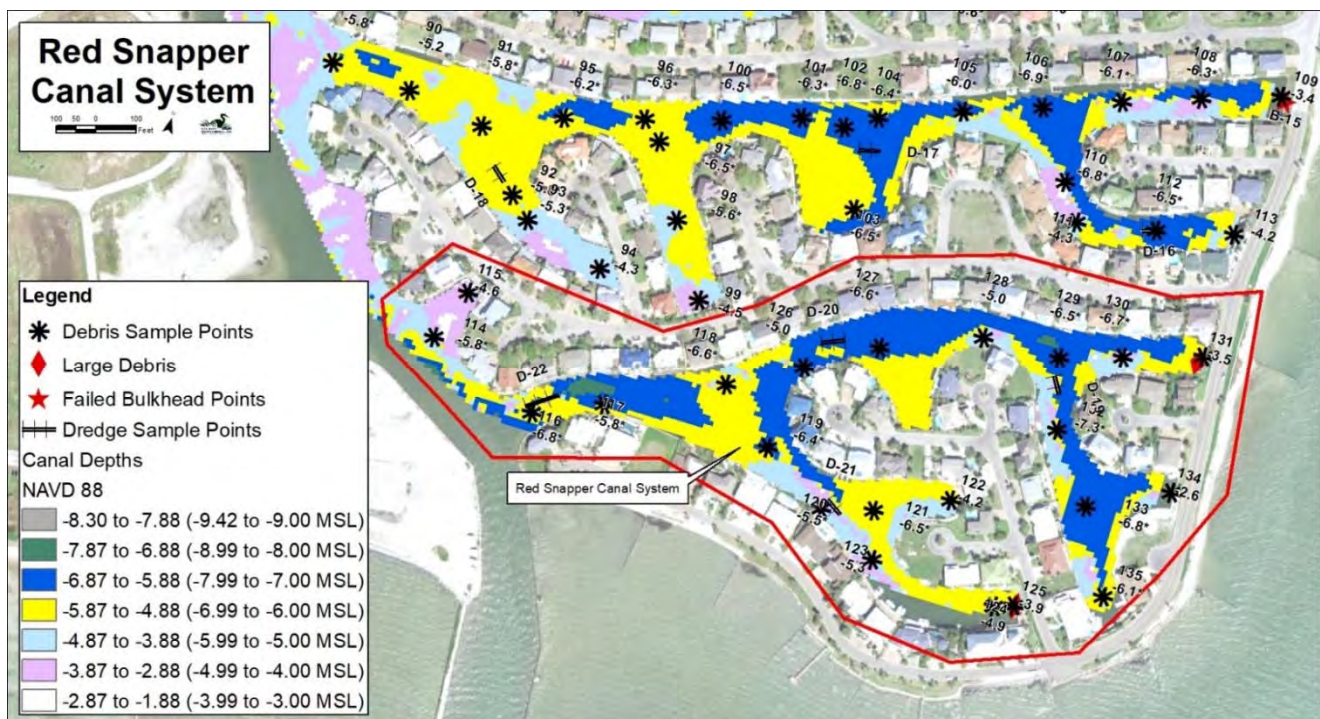
Visible bulkheads along Red Snapper Canal System showed no obvious signs of failure. Not all bulkheads were visible due to docks, boat slips, and other obstructions.

The Red Snapper Canal System debris sampling included twenty-two grab sample points and four 50-foot linear dredge. Debris found at these samples included metal, fishing line, partial shingles, plastic, wood, and organic matter. The organic matter classification consists of leaves, sticks, and other various small organic plant debris. In the Red Snapper Canal System, one piece of large debris was located that could not be removed for identification. Typically, debris found was located within the top six inches of sediment. Sample locations are shown in the map below and a breakdown of the debris is included within the table.

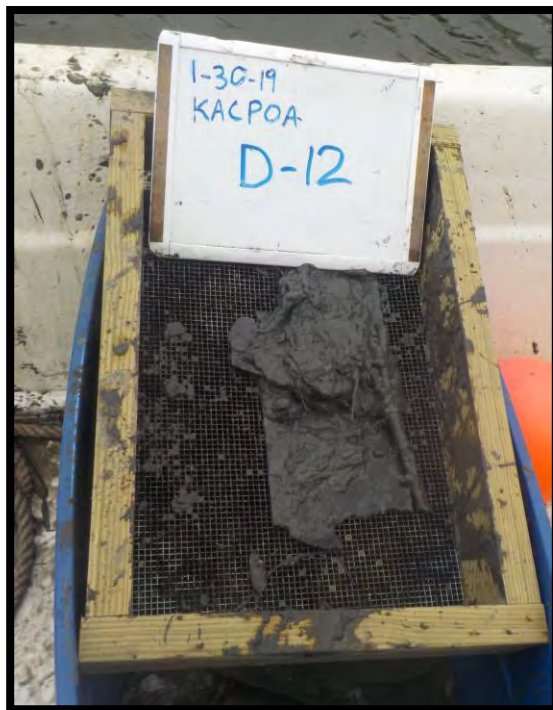
Sample 12 collected by 50-foot linear dredge.

D-11 was mislabeled as D-12.
Total number of dredge
sample points is 21.

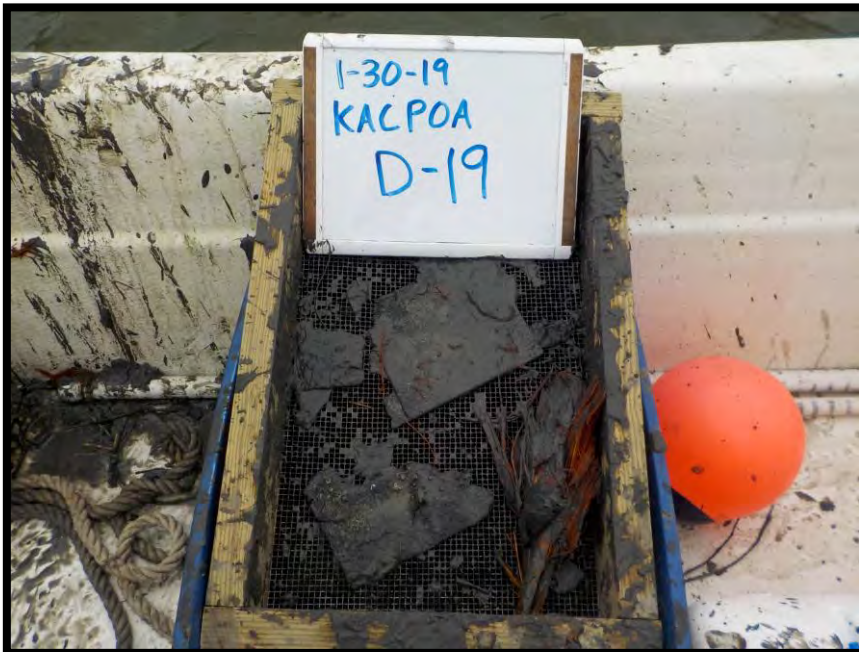
Sample 19 collected by 50-foot linear dredge.
