MOTT
MACDONALD

Key Allegro Preliminary Bulkhead Repair Engineering Analysis

Technical Memorandum

October 17, 2017

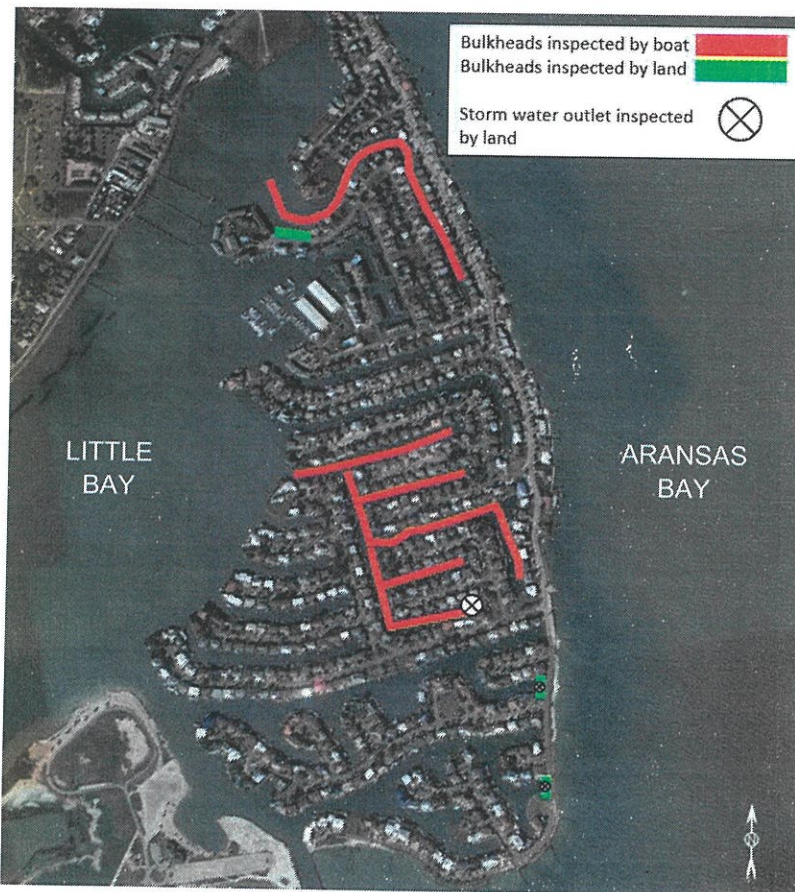
Figure 3: Reviewed bulkheads

A visual review of the current state of Key Allegro bulkheads took place during a site visit by Mott MacDonald on August 10, 2017. The review, conducted by land and by boat as shown in Figure 3, primarily focused on bulkheads constructed during phases 1-3, the oldest bulkheads in Key Allegro. Storm water outlet penetrations through aging and failed bulkheads present additional difficulties for bulkhead repairs around Key Allegro. Several storm water outlet locations were inspected and will be included in the repair alternatives.
